Inspection Report
Minerals Regulatory Program
Report Date May 2, 2006

Mine Name: T&M Holdings
Operator Name: Decorative Landscaping

Permit number: S/035/023
Inspection Date: May 1, 2006
Time: About 3:00-3:35 PM

M0350023, T&M Holdings Mine, Decorative Landscaping

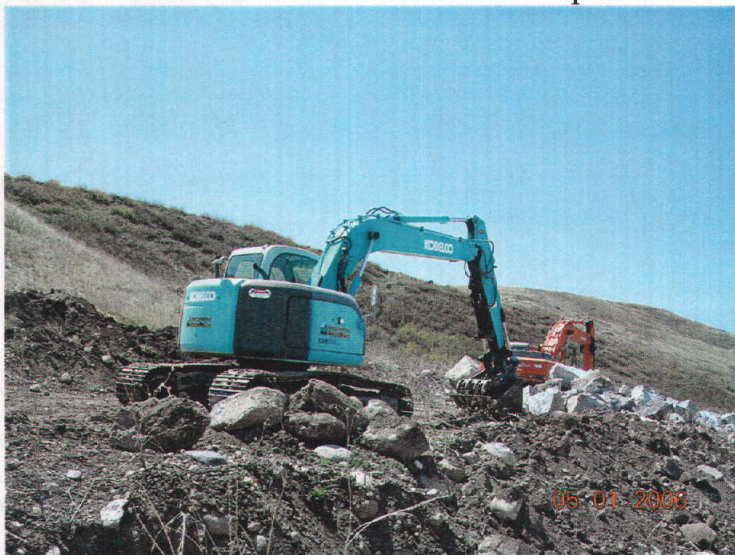
The operator has been taking rock from two unpermitted areas, one of which is the subject of ongoing enforcement action. At the west end of Bluffdale Sand and Gravel's disturbed area, Decorative Landscaping has been using a trackhoe with a hammer attachment to break rock and has apparently been hauling it away (Photo 1).

Photo 1. This photo was taken at Bluffdale Sand and Gravel's disturbed area and shows a trackhoe and a trackhoe with a hammer attachment (orange).

None of the operations I viewed are included in a Notice of Intention, reclamation bond or reclamation contract, so I will be issuing cessation order MC2005-03-03-01.

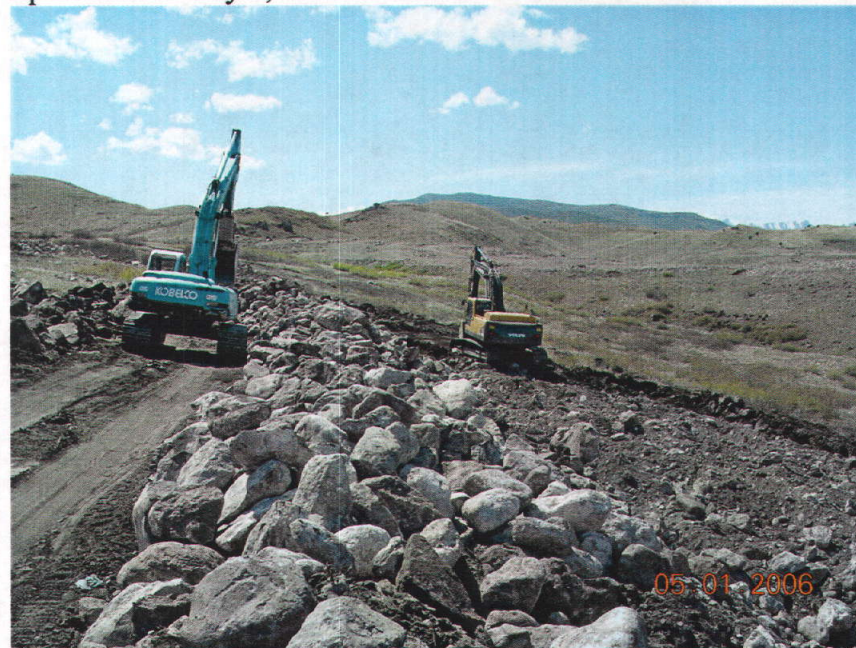
Closer to the permitted area, the operator has begun mining a previously-undisturbed area (Photos 2 and 3). I used the GPS unit to map the area, and it is about two acres (see attached map). The area of new disturbance may actually be slightly larger.

Photo 3. Another view of the disturbed area near the T&M Holdings Mine (M0350023).

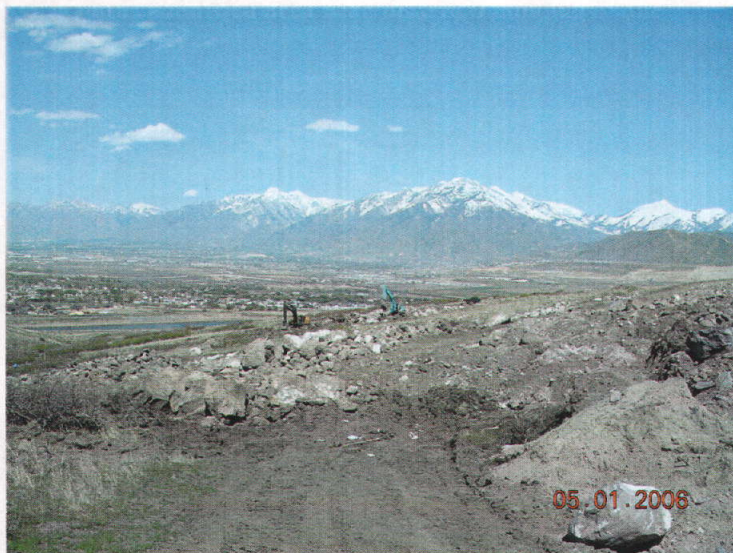
Photo 2. View looking approximately northeast at a new disturbed area near the T&M Holdings Mine.
